# HIGHWAY RESEARCH RECORD

Number 386 | Traffic Safety Barriers,  
Lighting Supports,  
and Dike Slopes

HIGHWAY RESEARCH BOARD

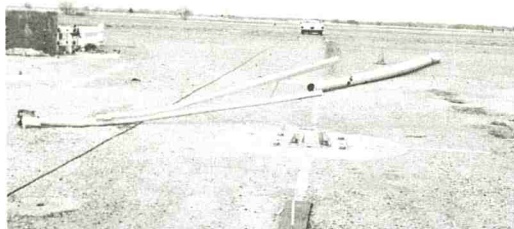
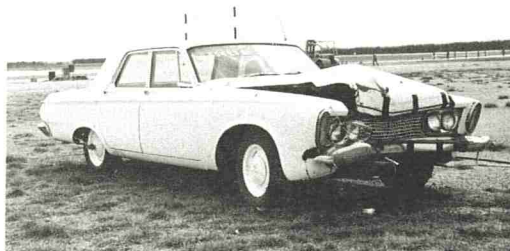
Figure 9. Luminaire support and vehicle after Test LS-5.

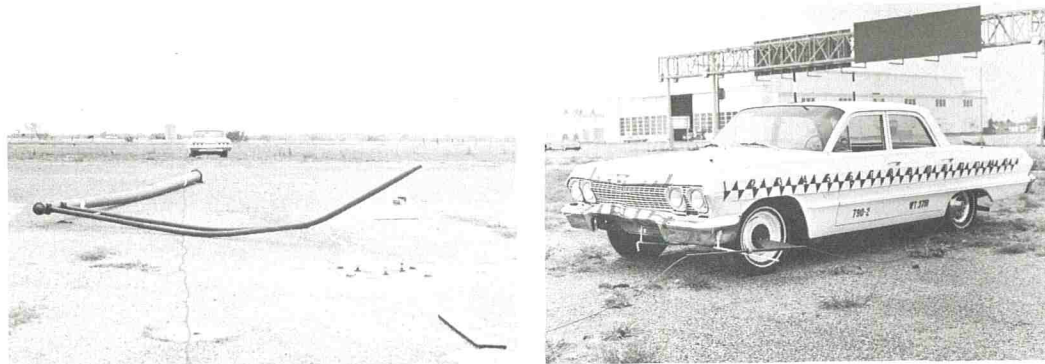
Figure 17. Luminaire support and vehicle after Test LS-9.
